# IMPACTS OF CLIMATE CHANGE ON THE HISTORIC BUILT ENVIRONMENT:

## A REPORT & GUIDE

ULSTER ARCHITECTURAL  
HERITAGE

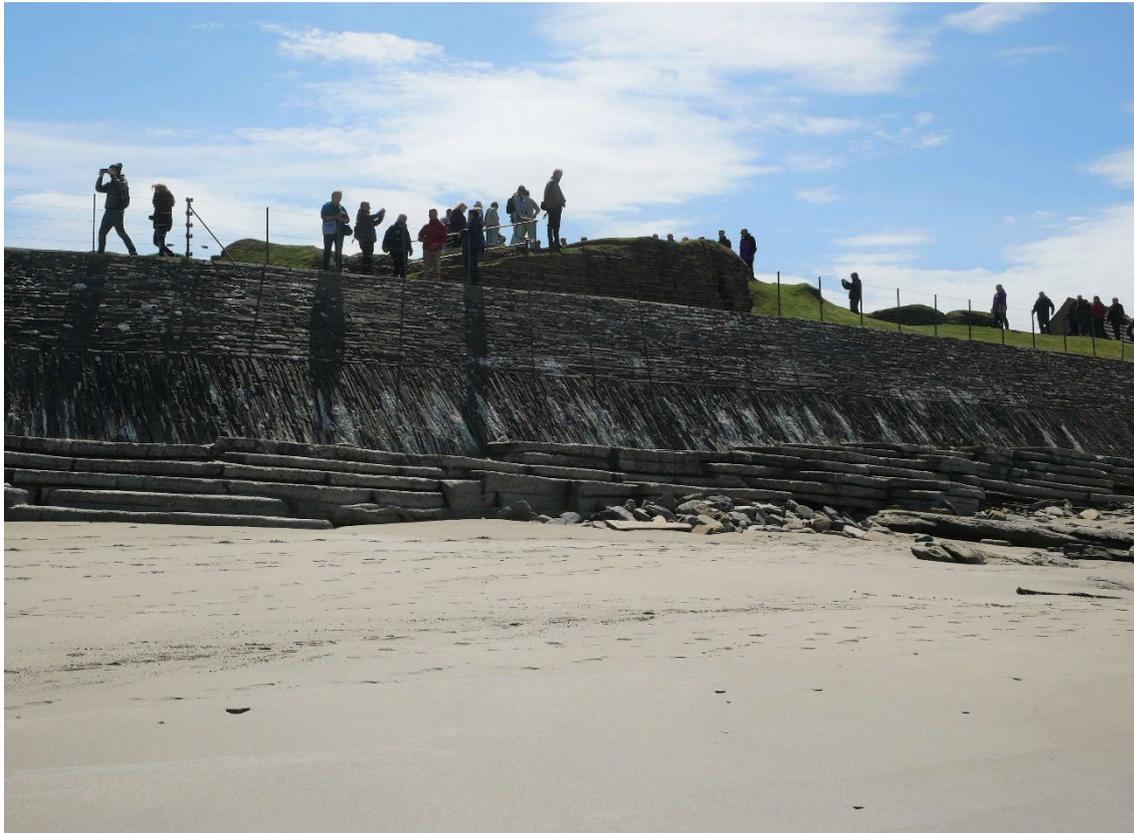
FIGURE 7. SEA WALL AT SKARA BRAE (IMAGE CREDIT: ORKNEYOLOGY.COM)

Skara has been protected by a substantial sea wall since the 1920s, which itself is now threatened by tidal undercut. It seems probable that the wall will be strengthened but inevitably that will have an effect on the neighbouring unprotected coastline. So, one aim is satisfied and another is potentially threatened. Similarly with Orkney now a Cruise Ship destination the detrimental effect of mass tourism footfall on the site is also a significant factor. Such are the problems facing managing authorities worldwide who are now also having to adapt their plans to suit global concerns regarding both climate change and pandemic risk assessment.

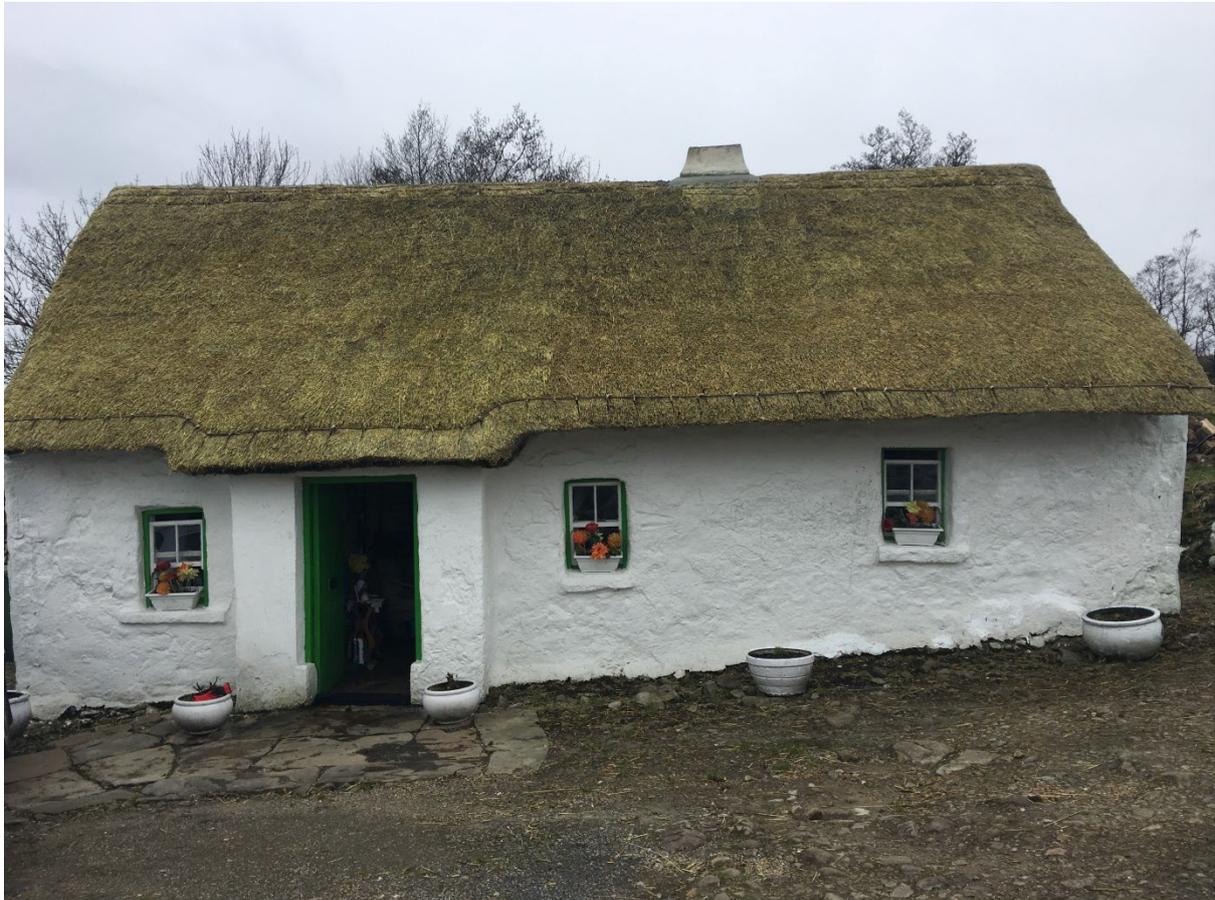
FIGURE 8. MULLYLUSTY COTTAGE, 2019. IMAGE CREDIT: ULSTER ARCHITECTURAL HERITAGE

At Mullylusty, Belcoo, County Fermanagh, private owner Margaret Gallagher has over a number of years noticed the impact of changing weather patterns on the thatch at her Grade A listed stone walled cottage. In particular, over the 70 years she has lived in the cottage, Margaret notes that the period of time that a thatch will last before repairs are required is much shorter. She has observed that periods of heavy rain and occasional winter snow now seem to continue later into the year, with spring being more of a continuation of winter than it used to be. Opportunity for the thatch to dry out is less frequent than it used to be, causing more rapid deterioration of the material, particularly causing slipping at the rigging and rotting of the scallops.

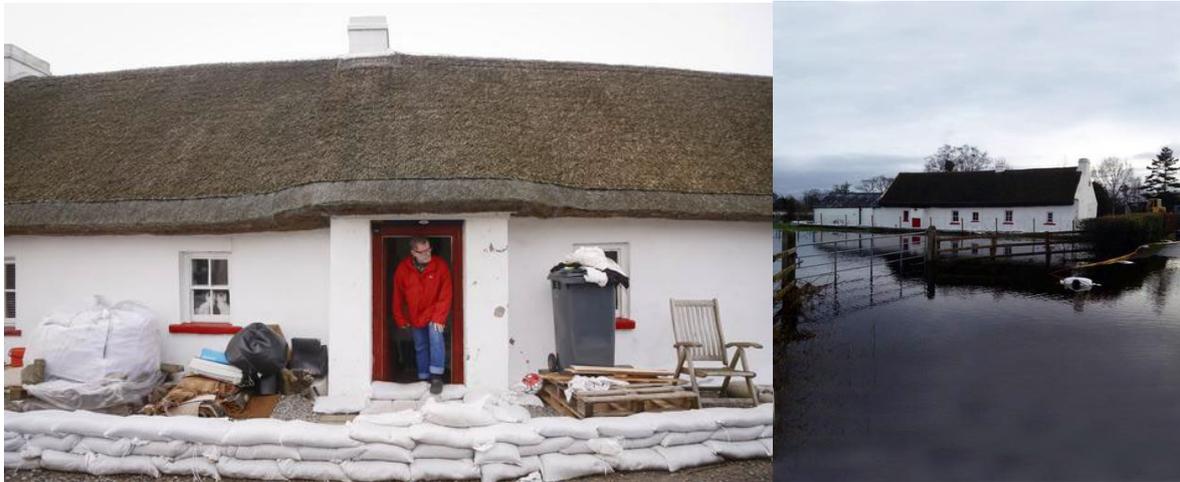
FIGURE 9. COTTAGE AT DERRYCUSH ROAD, IMAGE CREDIT: BELFAST TELEGRAPH, FEBRUARY, 2016.

In 2016 at Derrycush Road, Cloncore, Portadown, County Armagh, Dan and Kate McQuillan were faced with the impact of flooding on their B+ listed<sup>36</sup> thatched, mud walled cottage. During the flooding event, action was taken by the owners and the Rivers Agency to try to protect the property with sand bags and pumps. Unfortunately this was not wholly effective as the flooding that surrounded the building on all sides caused significant damage<sup>37</sup>.

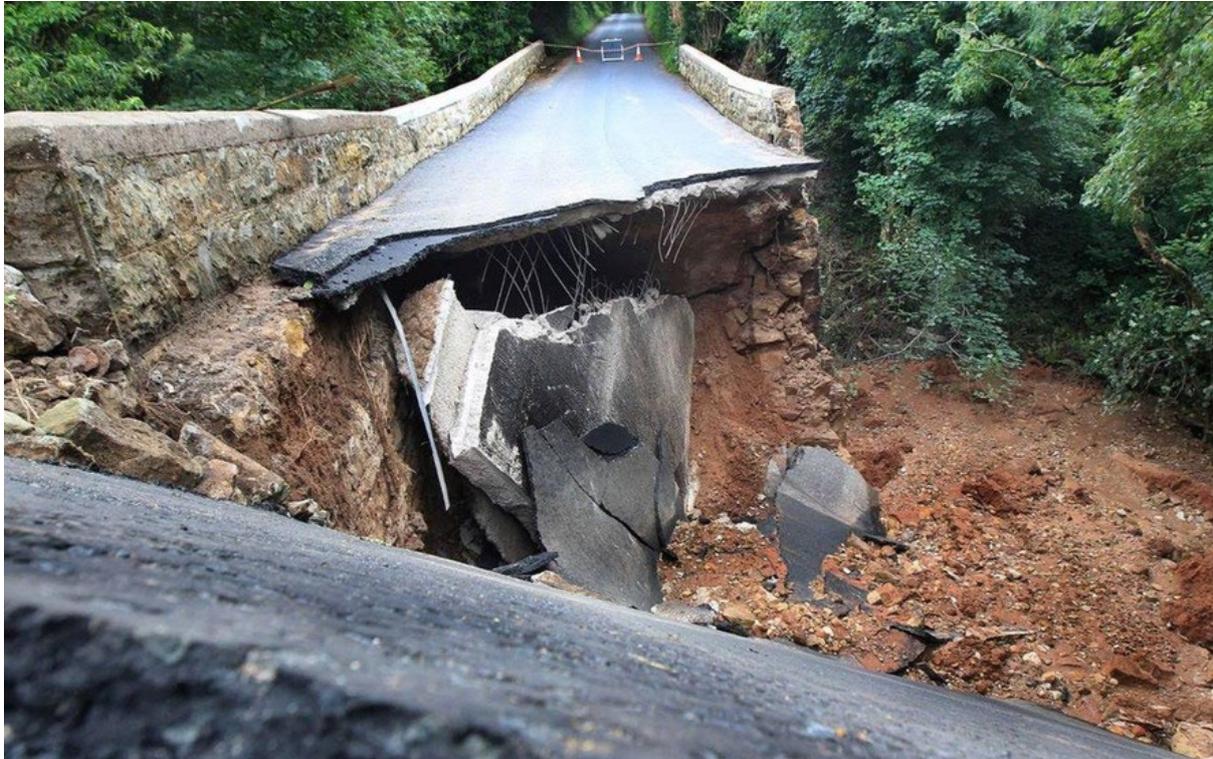
FIGURE 10. GLENRANDAL BRIDGE, CLAUDY. IMAGE CREDIT: MARGARET MCLAUGHLIN VIA THE IRISH NEWS, AUGUST, 2017.<sup>38</sup>

In late August 2017, is estimated around 60% of the rainfall expected for the entire month fell in just nine hours in counties Londonderry, Tyrone and Donegal. Roads, sports grounds and private homes were damaged in the resulting floods, including the government owned, B2 listed Glenrandal Bridge<sup>39</sup>. This stone bridge, with its abutments and carriageway, built c.1800s<sup>40</sup> was one of five bridges damaged almost 'beyond repair' out of a total of 85 structures affected by the floods.<sup>41</sup> After major repair by the Department for Infrastructure, at a cost of £420,000, the bridge was reopened in 2020<sup>42</sup> forming part of a £20 million repair bill associated with this particular flood event.

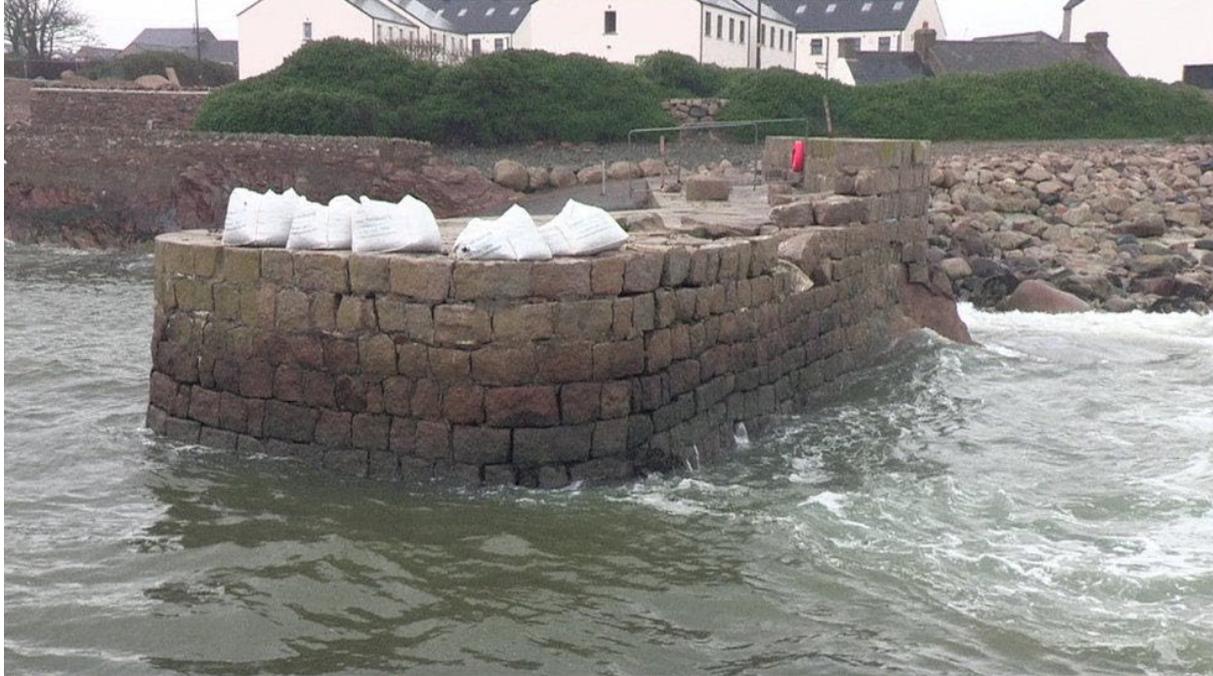
FIGURE 11. ANNALONG HARBOUR

The harbour at Annalong, County Down is a B2 listed stone structure that dates back to the 1840s. It was formerly used to support the local fishing industry and the export of local, Mourne granite. Over many years having proven resilience, in recent years the structure was seen to fall into an increasing state of disrepair.<sup>43</sup> The effect of high impact, low frequency events such as storms and tidal surges, have, over a number of years, caused damage to the pier. In 2018 the local community raised the issue, with owners, Newry Mourne and Down District Council but no action was taken at that time. However, following significant damage caused by a storm in early 2021, work began on the 'deconstruction and reconstruction of the pier' utilising 'all of the traditional materials that were used 150 years ago'<sup>44</sup>.

This example demonstrates how the accumulation of damage from exposure to low frequency, high impact events such as storms can weaken historic assets in coastal locations. It also highlights the requirement for regular and thorough condition assessment of such structures in exposed locations especially because of the projected increase in the frequency of storms associated with a changing climate.

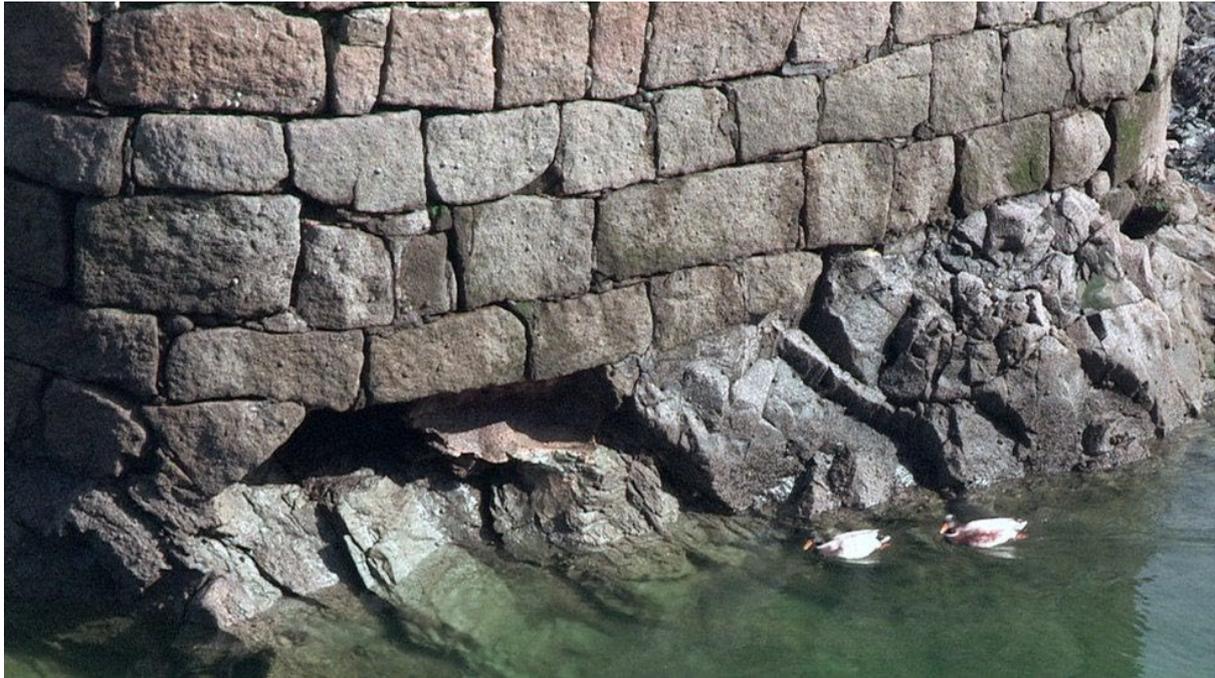
FIGURE 12. DAMAGE TO ANNALONG HARBOUR WALL

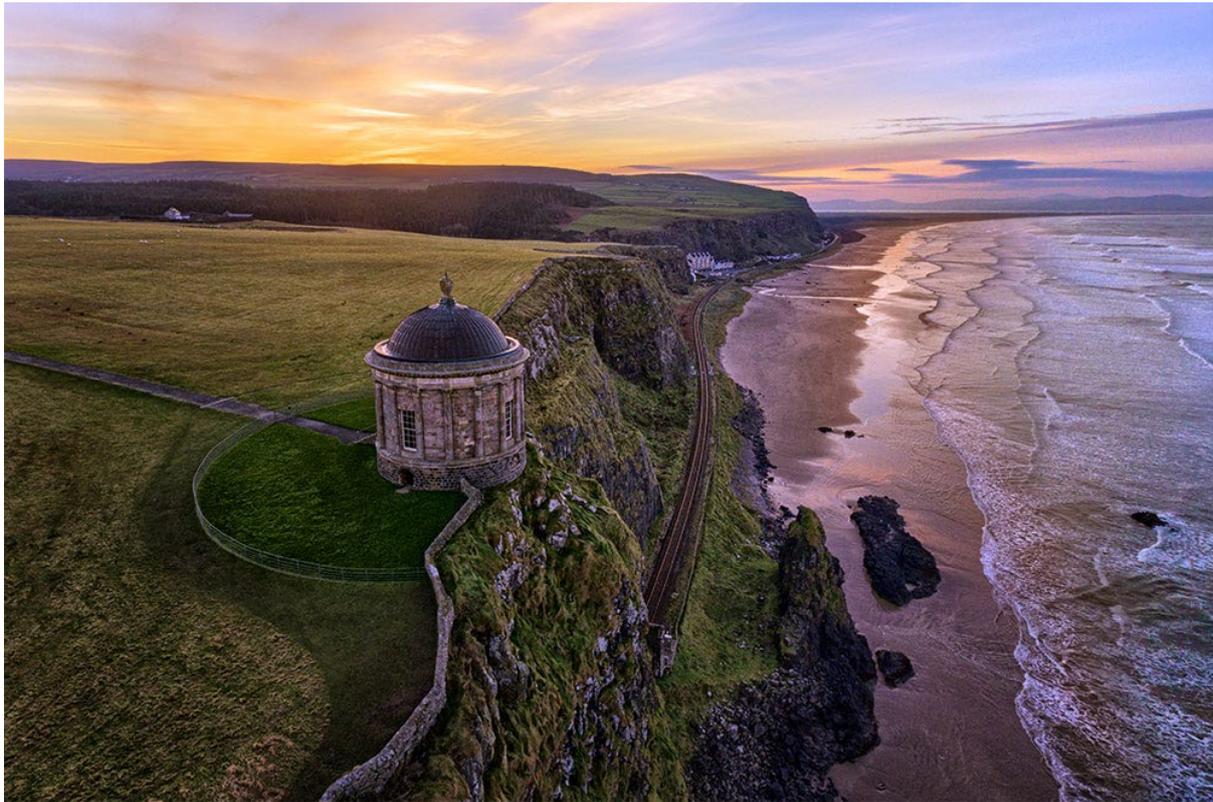
FIGURE 13. MUSSENDEN TEMPLE IMAGE CREDIT: GARETH WRAY PHOTOGRAPHY

At Downhill, County Londonderry, on the Causeway Coast, in the 1990s, the National Trust identified risk to the Grade A listed Mussenden Temple. The striking cliff edge setting contributes significantly to the iconic status of this structure but also places it at greater risk of loss through cliff collapse from marine erosion undercutting the cliff face.

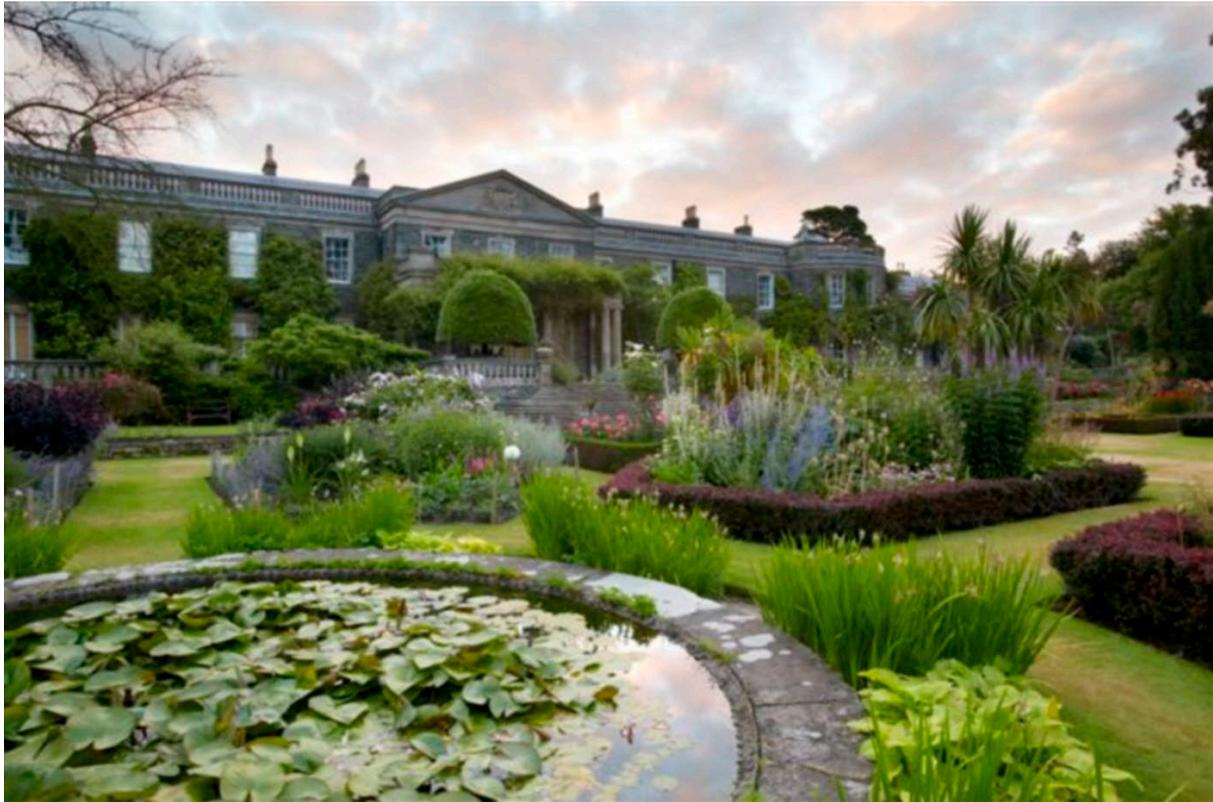
FIGURE 14. MOUNT STEWART HOUSE AND GARDENS. IMAGE CREDIT: VISIT ARDS AND NORTH DOWN<sup>46</sup>

Mount Stewart house and gardens are one of the best known properties owned and managed by the National Trust in Northern Ireland. The estate is located on the eastern shore of Strangford Lough on the Ards Peninsula in County Down and portions of the formal gardens are at risk from the effects of rising sea level and salt water incursion to groundwater. The National Trust have been developing adaptation plans to mitigate these risks<sup>47</sup> including enhancement of the existing Sea Plantation on the shores of the lough which provides a protective barrier between Strangford Lough and the house and gardens.

However recent climate change studies have suggested that the Sea Plantation will struggle to protect the property over the forthcoming decades and the National Trust have begun a long-term plan to future proof the house and gardens with the possibility of relocating the main car park and replacing it with a dense shelterbelt of trees and shrubs that will take over the protective role of the Sea Plantation. <sup>49</sup>

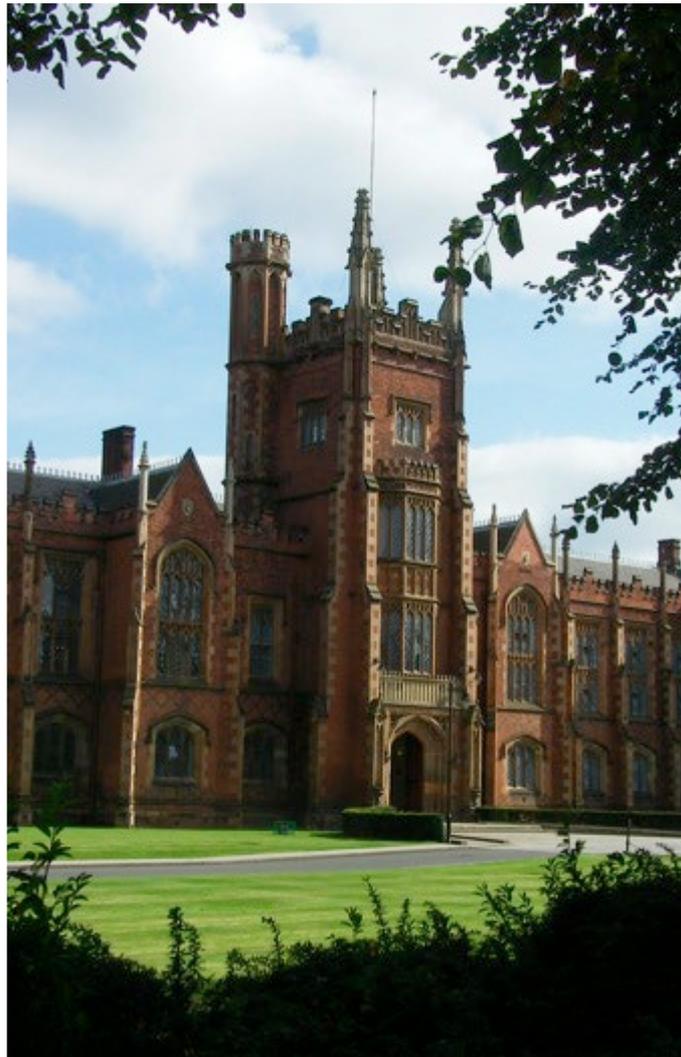
FIGURE 17. CENTRAL PORTION OF THE LANYON BUILDING, QUEEN'S UNIVERSITY BELFAST.

The Lanyon Building, Queen's University Belfast, is another of Northern Ireland's iconic historic structures that underwent a major programme of refurbishment works in 2019 in response to long-term weathering related deterioration of its external fabric. The works involved the repair and, where necessary, like-for-like replacement of decorative stone detailing in the form of pinnacles, finials and crenelated balustrades. In addition, because of the increasing frequency of extreme rainfall events, rainwater goods were upgraded with installation of larger capacity lead gutters, overflows and outlets, all designed to fit with the character of the existing fabric and detailing.

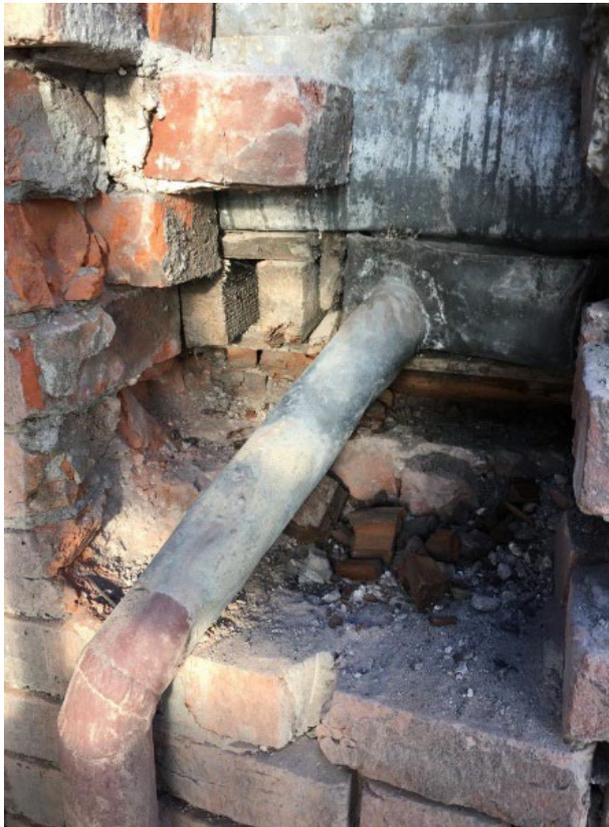
**FIGURE 18A.**

*An original shallow gutter box and 80mm diameter outlet pipe discharged to a hopper and a 100mm square cast iron down pipe.*

Ensuring that rainwater is efficiently removed from any building is an important component of long-term maintenance strategies. The upgrading of rainwater goods on the Lanyon Building is an example of how a structure can be sympathetically and appropriately adapted to better cope with a greater frequency of intense rainfall events associated with changing weather patterns.<sup>50</sup>

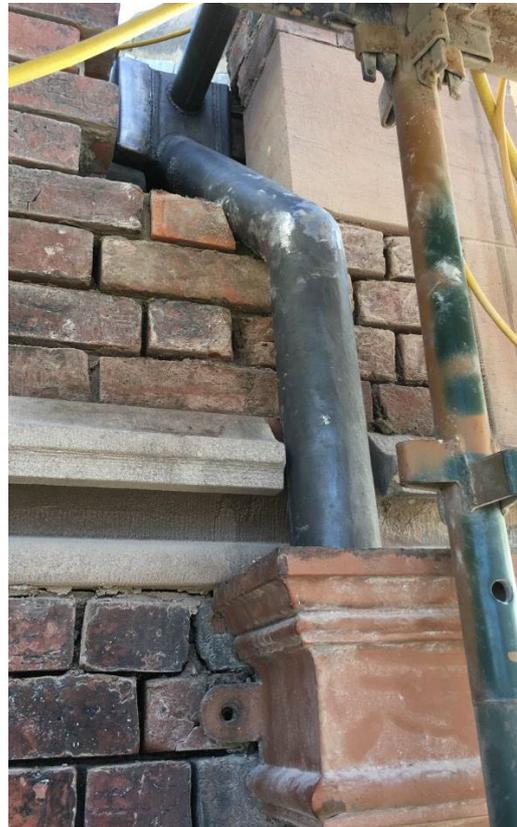
**FIGURE 18B.**

*A bigger gutter box was formed where the outlet pipe was increased in diameter to 100mm with a 75mm overflow pipe added*

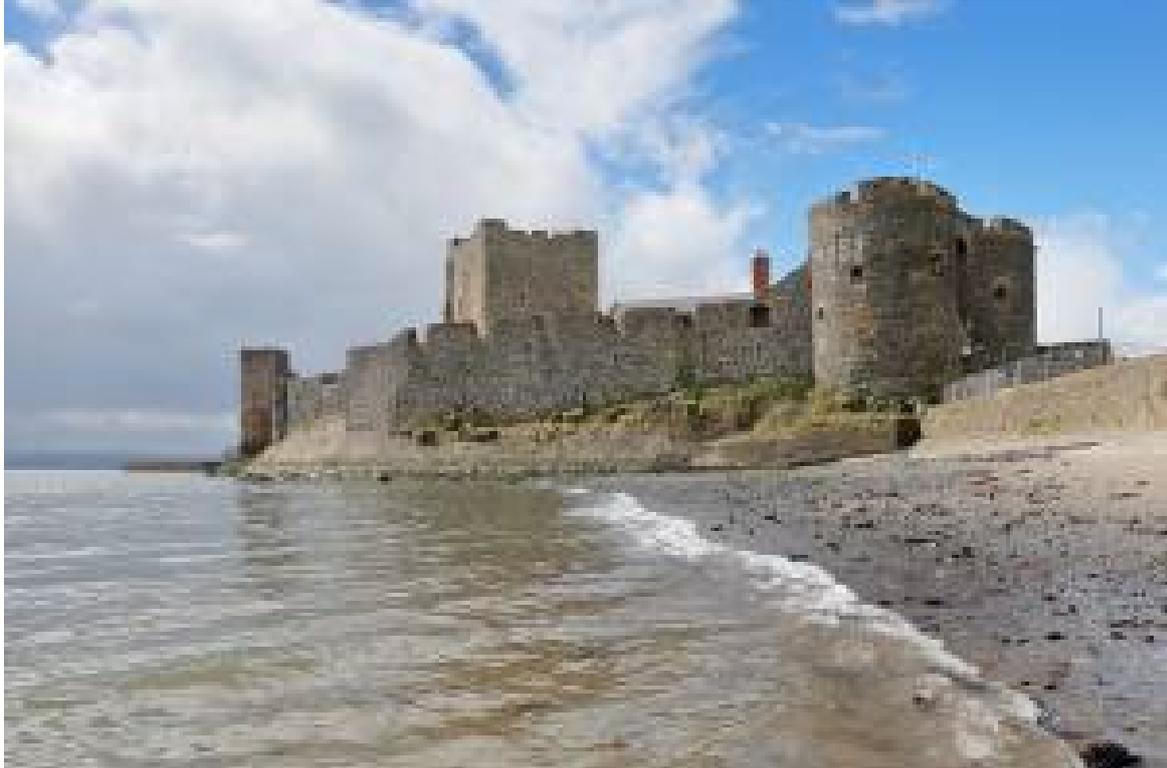
FIGURE 19. CARRICKFERGUS CASTLE. IMAGE CREDIT: DEPARTMENT FOR COMMUNITIES

The early twentieth century flat roof at Carrickfergus Castle was allowing significant ingress of rainwater, resulting in saturated masonry and deterioration of the condition of the wider building fabric. In 2019 the building's owners, the Department for Communities: Historic Environment Division, embarked on a programme of works to address the problem.

The old flat roof was replaced with a new roof that was historically authentic. This featured two individual timber truss slate roofs, with lead valleys and louvered lanterns on top to ventilate the interior; thereby providing effective protection from the weather and good insulation.<sup>51</sup>

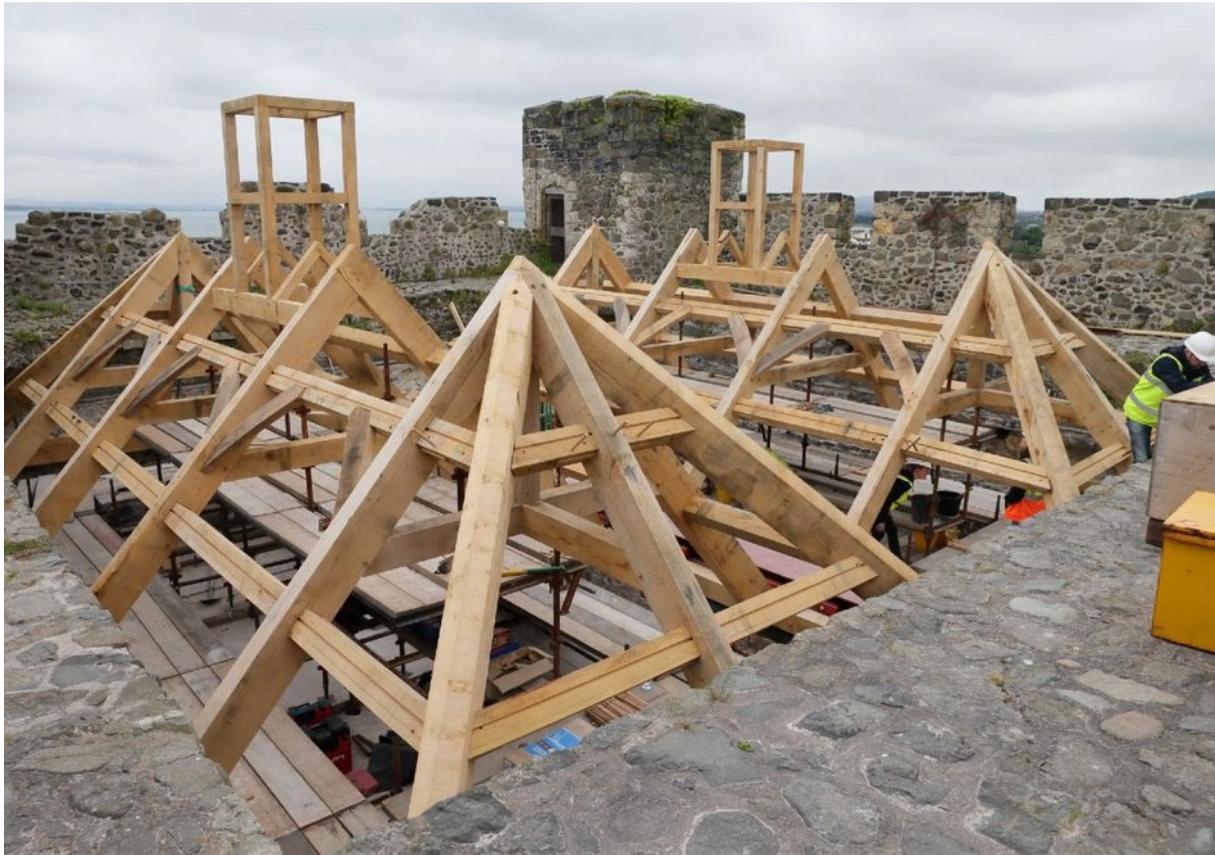
FIGURE 20. CARRICKFERGUS CASTLE, REPLACEMENT AUTHENTIC ROOF STRUCTURE
